RE: Camp Boyhaven Dam Assessment
3430 Boyhaven Road
Middle Grove, New York

M.J. Engineering and Land Surveying, P.C. (MJ) is pleased to provide you this report associated with the structural assessment of the upper and lower dam structures located at Camp Boyhaven, Middle Grove, New York.

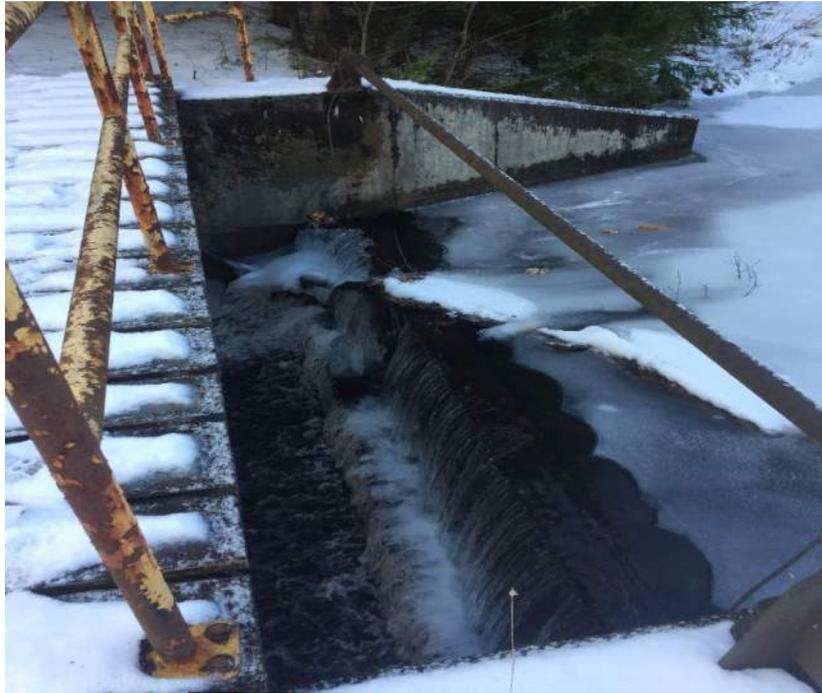
- 3) The steel liftgate weir assembly has surface corrosion and it is not clear how the assembly is operated as there was no lifting mechanism. (Photo 1)

- 4) There is debris at the crest of the concrete spillway. The debris should be cleared to prevent obstructing the water flowing over the crest. (Photo 1)

Photo 1: Upper Dam liftgate weir assembly

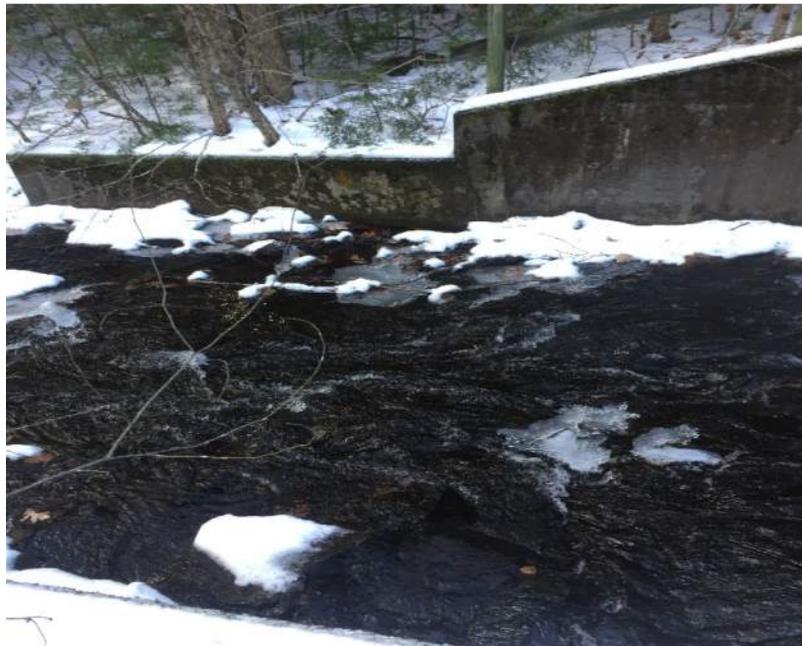
- 5) The concrete spillway walls and training walls are in good condition. (Photo 2)
- 6) Vegetation overgrowth is prevalent adjacent to the existing concrete training walls. The vegetation should be cleared within 5-feet of the training wall to prevent damage of the existing concrete. (Photo 3)

Photo 2: Upper Dam concrete walls

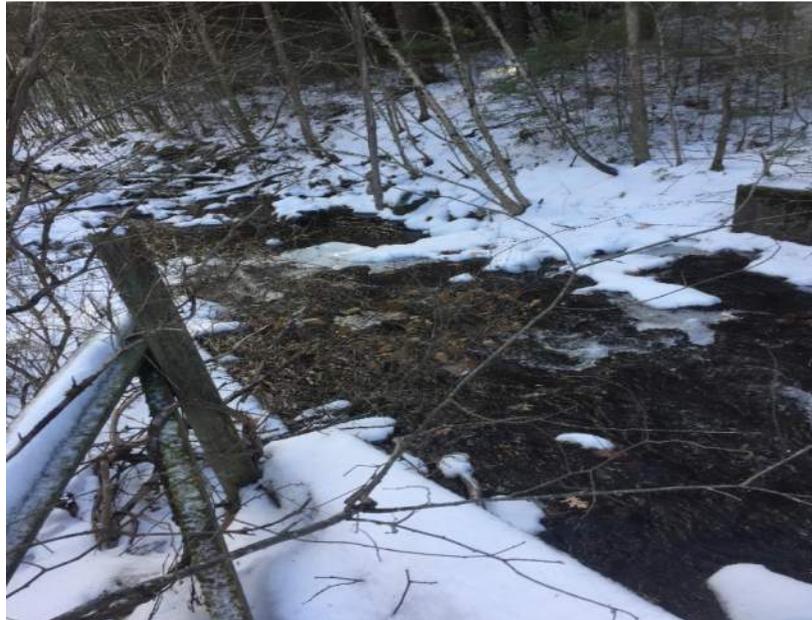
Photo 3: Upper Dam vegetation at spillway walls

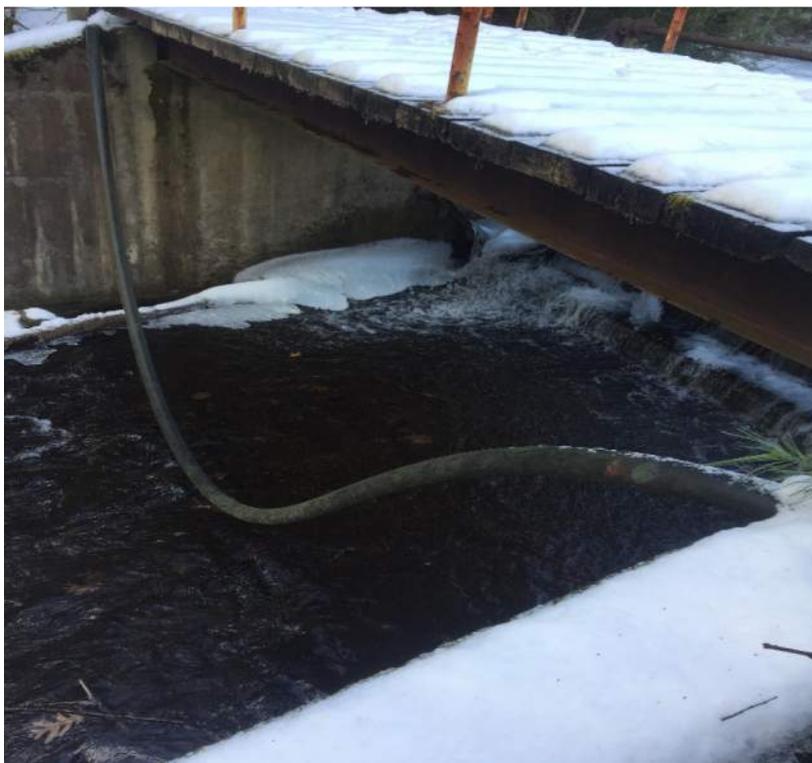
- 7) The steel of the pedestrian bridge has surface corrosion. There is no section on the steel girders. The steel should be cleaned and coated to extend the life of the bridge. (Photo 4)

Photo 4: Upper Dam surface corrosion of steel

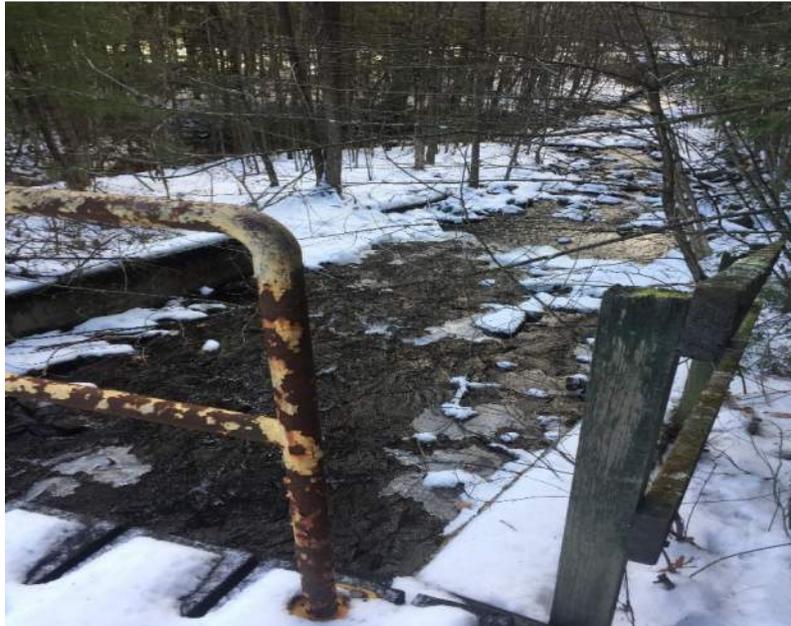
- 8) The handrail paint system on the pedestrian bridge has failed. The handrail should be cleaned and painted to extend the life of the handrail. (Photo 5)

Photo 5: Upper Dam handrail paint failure

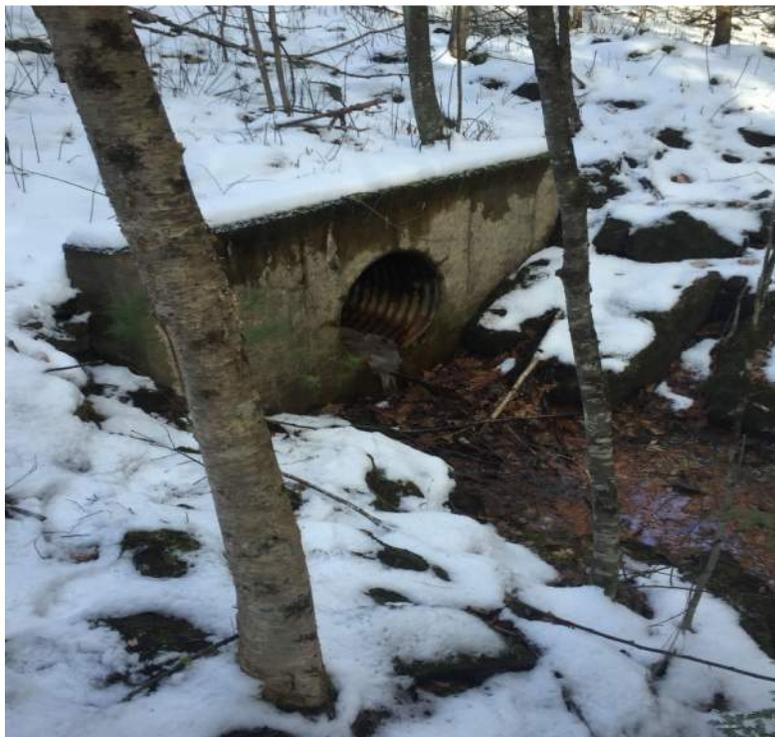
- 10) The low level outlet pipe and concrete headwall are in good condition. (Photo 6)
- 11) The low level outlet valve is located approximately 30-feet upstream of the earthen dam spillway with no access platform. An access dock and platform should be constructed from the earthen dam to the low level outlet valve. (Photo 7)

Photo 6: Upper Dam low level outlet pipe and headwall

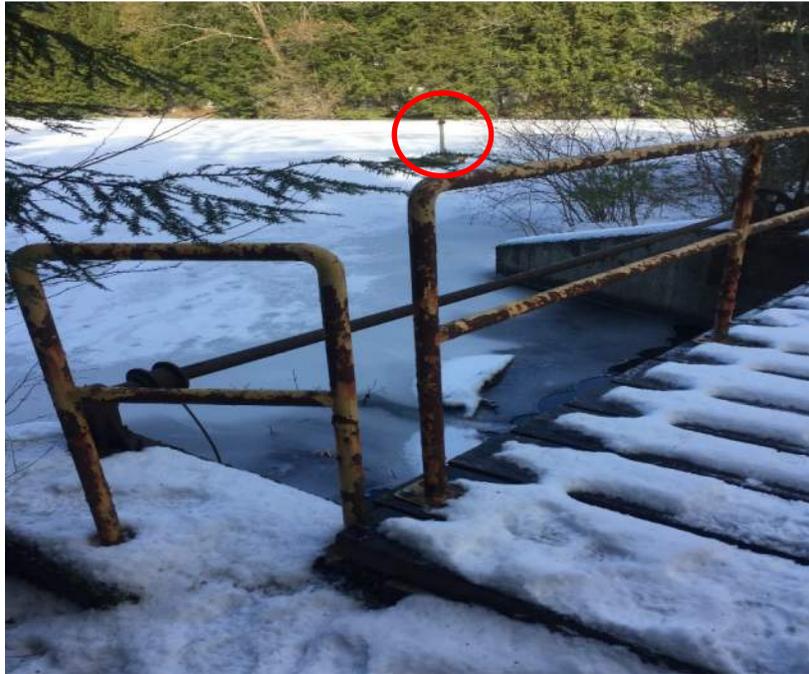
Photo 7: Upper Dam valve and platform

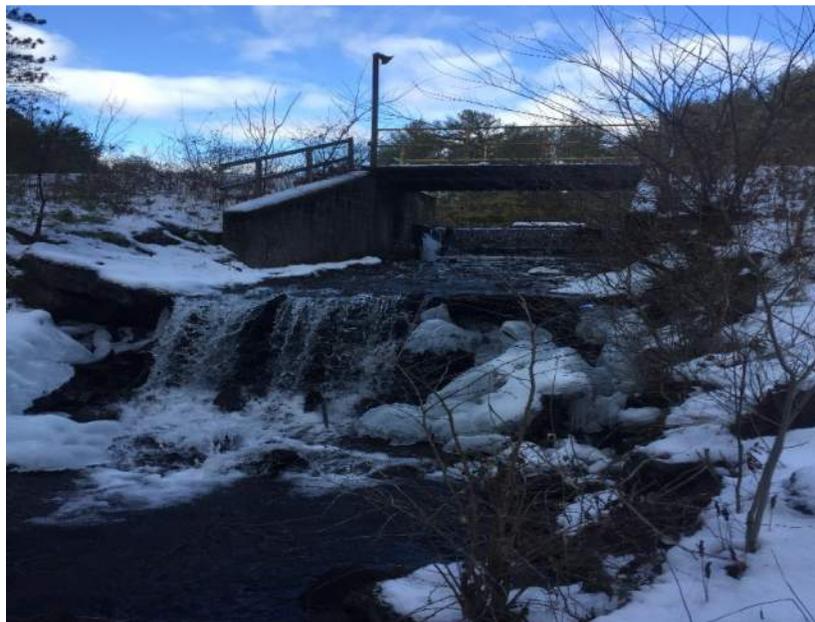
- 1) The dam structure is in good condition overall. (Photo 8)
- 2) The earthen dam section is in good condition. No seepage was noted at the downstream sections of the earthen dam.
- 3) The steel liftgate weir assembly has surface corrosion and it is not clear how the assembly is operated as there was no lifting mechanism. (Photo 9)
- 4) There is a large section of a tree and debris at the concrete spillway that should be removed prevent obstructing the water flowing over the crest and damaging the concrete. (Photo 10)

Photo 8: Lower Dam structure

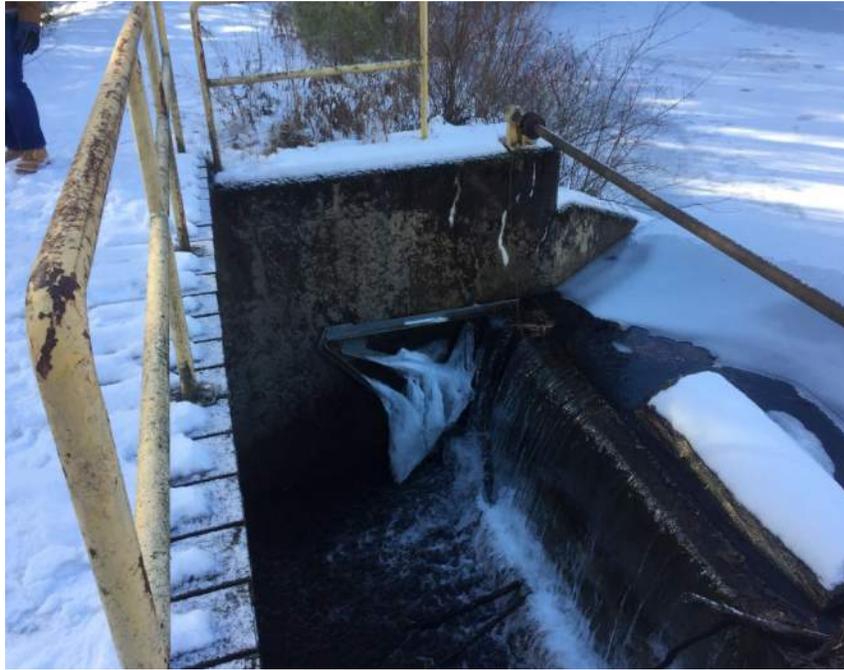
Photo 9: Lower Dam liftgate weir assembly

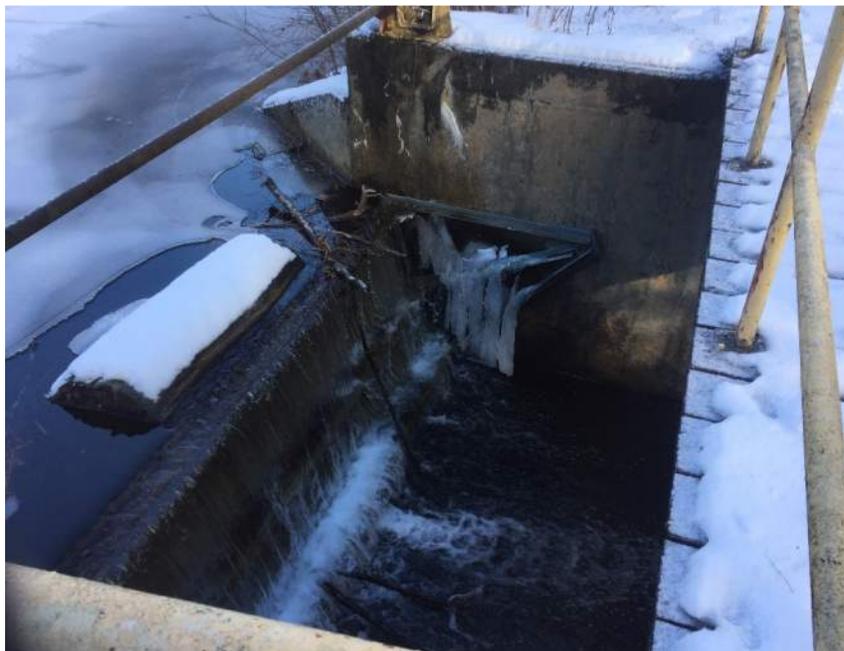
Photo 10: Lower Dam debris at spillway

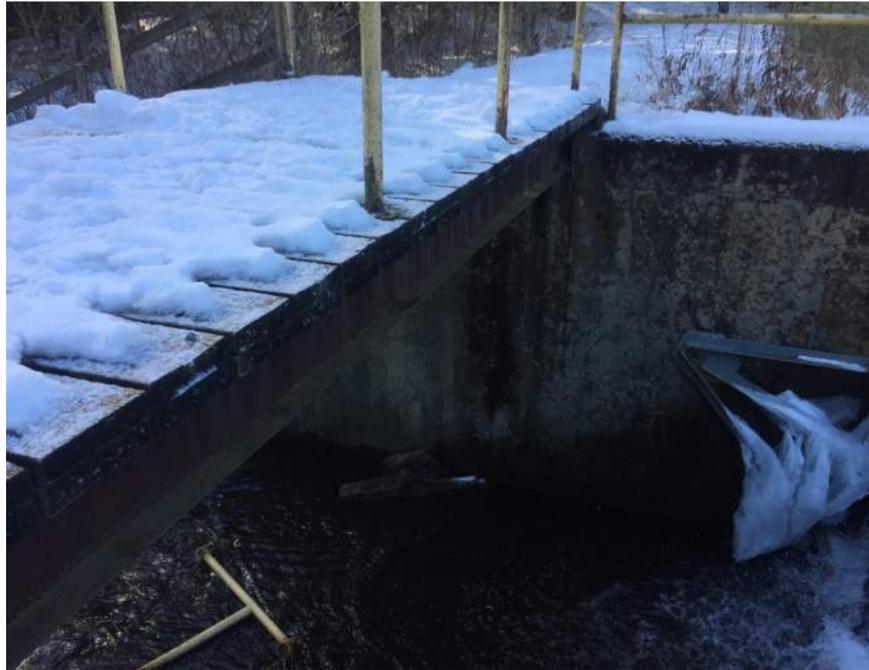
- 5) There is a section of handrail in the upper portion of the spillway apron slab that should be removed. (Photo 11)
- 6) The concrete spillway walls and training walls are in good condition. (Photo 12)

Photo 11: Lower Dam handrail on apron slab

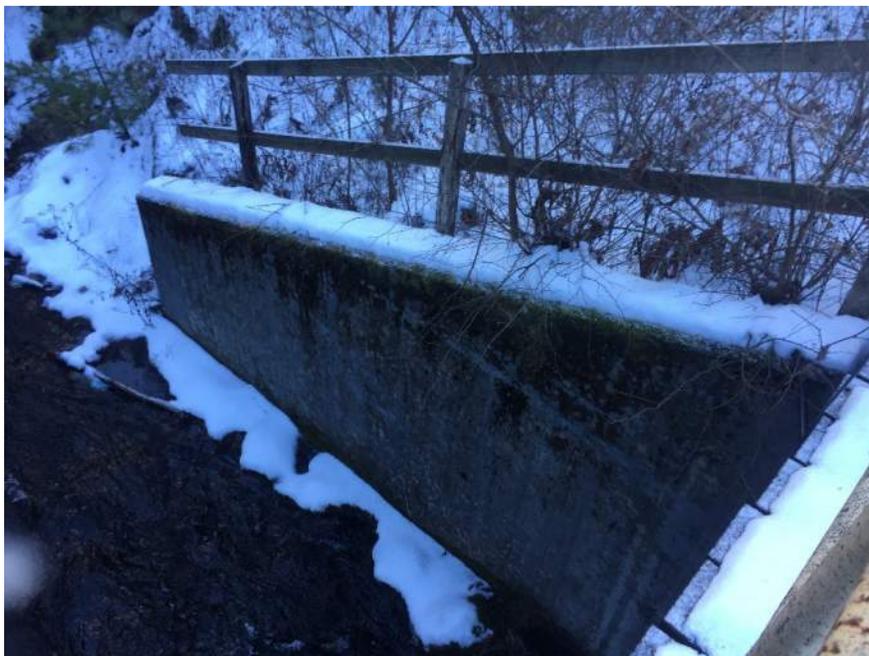
Photo 12: Lower Dam concrete spillway and training walls

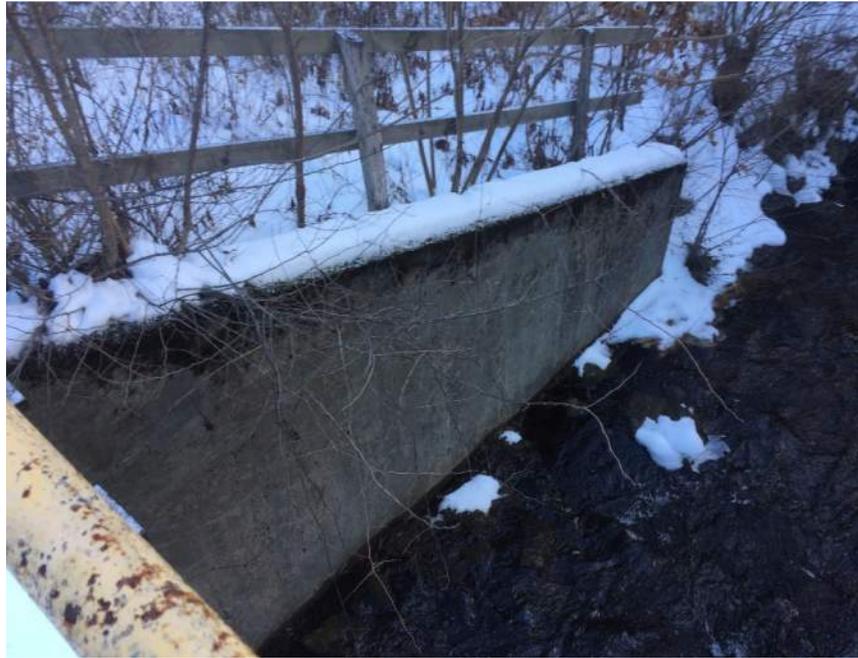
- 7) Vegetation overgrowth is prevalent adjacent to the existing concrete training walls. The vegetation should be cleared within 5-feet of the training wall to prevent damage of the existing concrete. (Photo 13)

Photo 13: Lower Dam vegetation at training walls

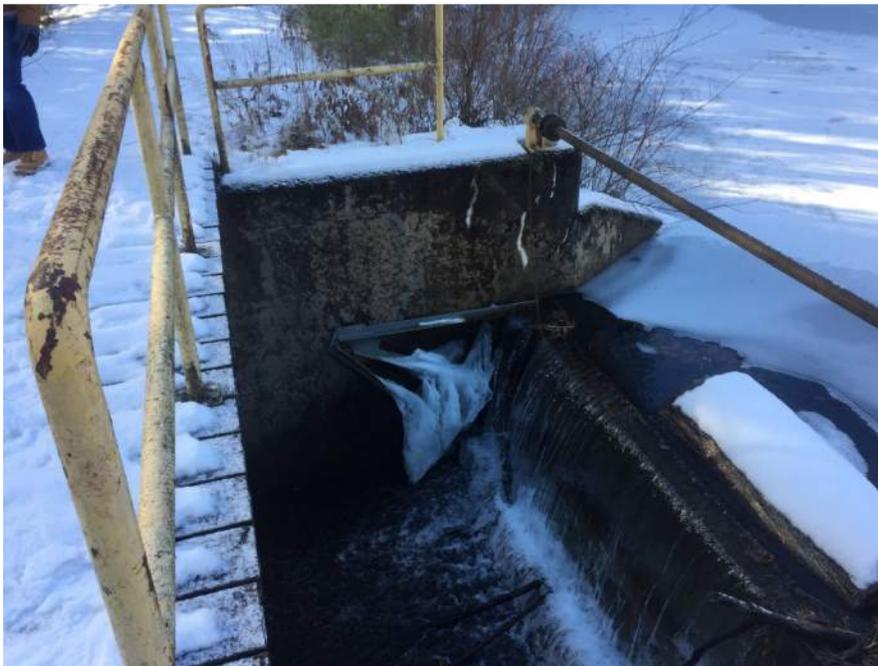
- 9) The handrail paint system on the pedestrian bridge is deteriorated. The handrail should be cleaned and painted to extend the life of the handrail. (Photo 14)

Photo 14: Lower Dam handrail paint deterioration

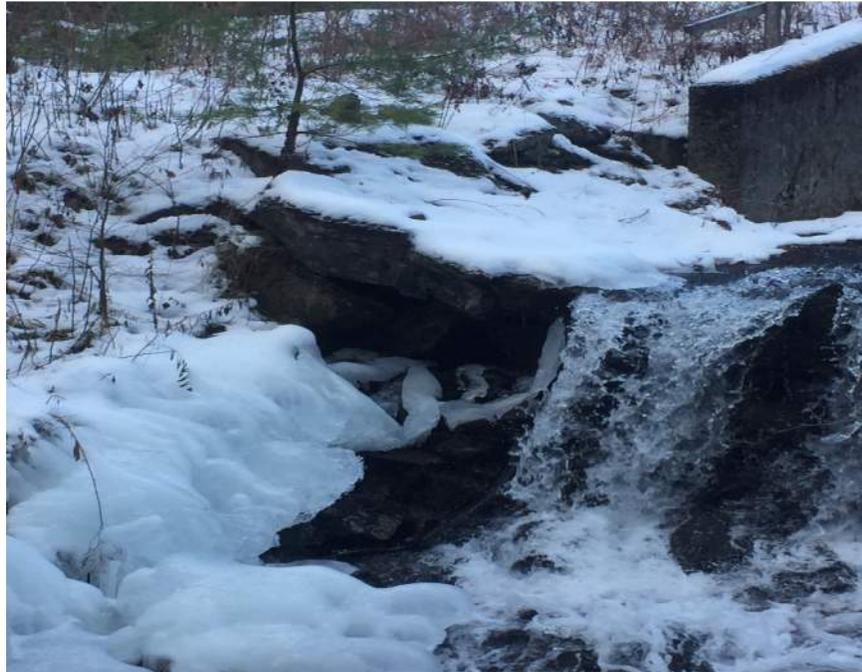
- 13) Erosion was noted at the south eastern corner of the upper concrete and grouted stone apron slab. This area should be repaired with rip rap and grout to prevent further deterioration. (Photo 15)

Photo 15: Lower Dam erosion at apron slab

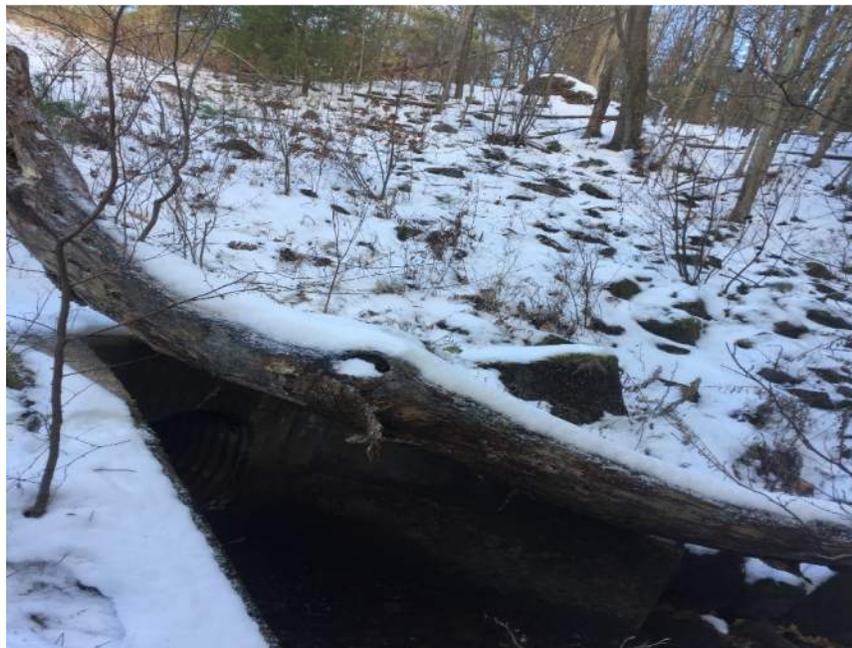
- 14) The low level outlet pipe, concrete headwall and training wall are in good condition. However, there is a fallen tree at the outlet that should be removed. (Photo 16)

Photo 16: Lower Dam fallen tree at low level outlet pipe

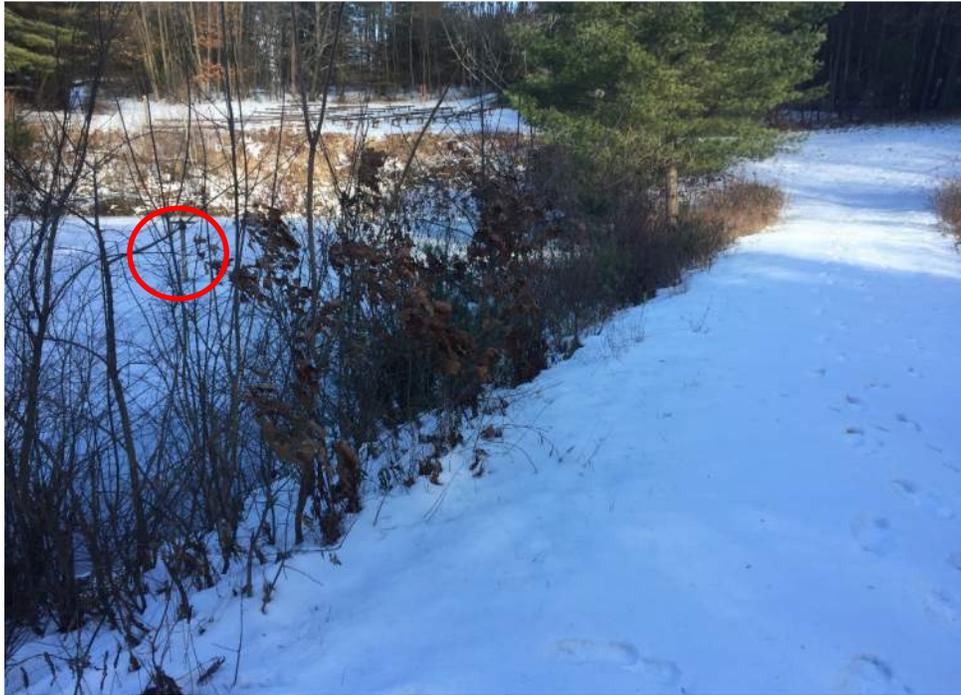
- 15) The low level outlet valve is located approximately 30-feet upstream of the earthen dam spillway with an access platform but no dock to access the platform. An access dock should be constructed from the earthen dam to the low level outlet valve platform. (Photo 17)

Photo 17: Lower Dam low level outlet valve
